# Field Report

# Intertidal Habitat and Marine Biota Survey of the Vallejo Marine Terminal Site, Vallejo, California

April 18, 2014

**July 2014**

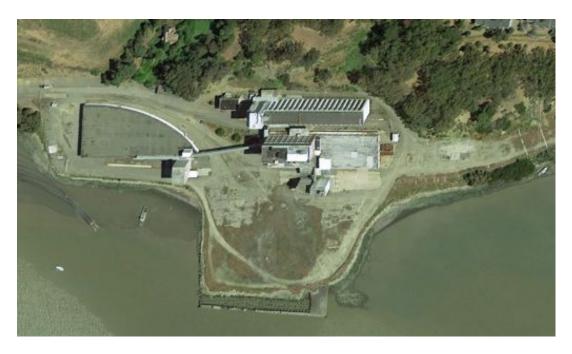
Figure 1-1. Existing shoreline conditions and intertidal habitats along the Vallejo Marine Terminal Site waterfront, Vallejo, California.

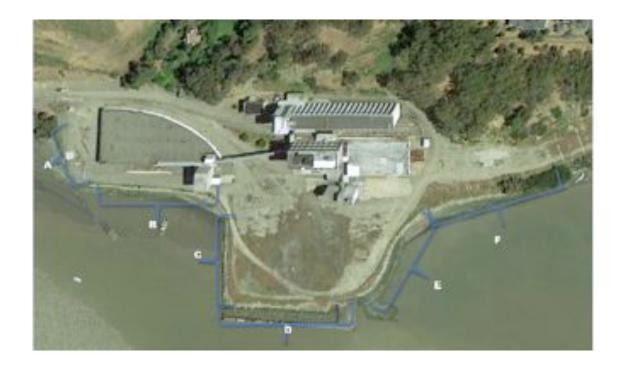
Figure 2-1. Vallejo Marine Terminal survey site locations.

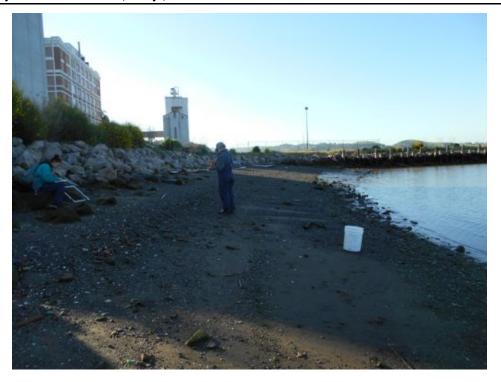
Figure 3-2 High, mid, and lower intertidal zone habitat along the pocket beach in survey segment B.

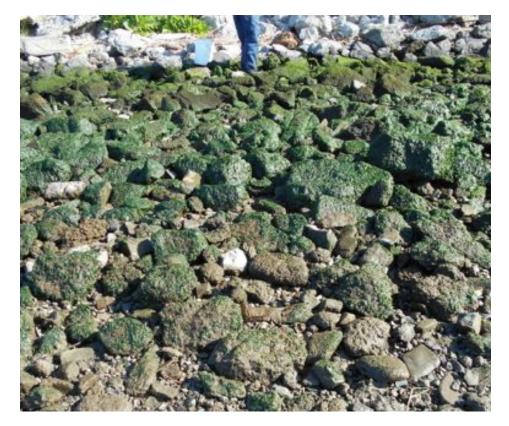
Figure 3-3 Leafy form of *Ulva spp*.

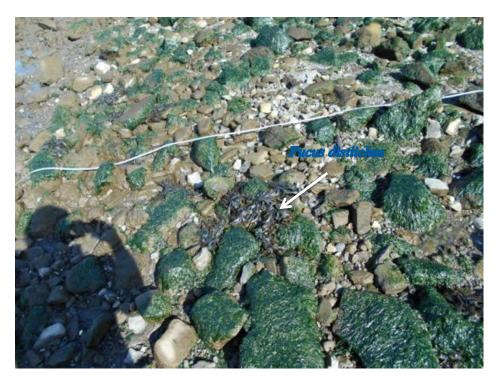
The mid intertidal zone consisted mostly of isolated large boulders, cobble, gravel, and course sand. Again, zones C and D differed in comparison, as they were mostly concrete rip rap that extended almost vertically from the upper intertidal zone to the lower intertidal zone and in some areas, subtidally (Figure 3-1). The mid intertidal zone was dominated by the leafy form of *Ulva spp*. (Figure 3-3). Other algae species seen included the filamentous form of *Ulva spp*., *Fucus distichus* (Figure 3-4), as well as an unidentified alga.

Figure 3-4 Segment F, Fucus distichus.

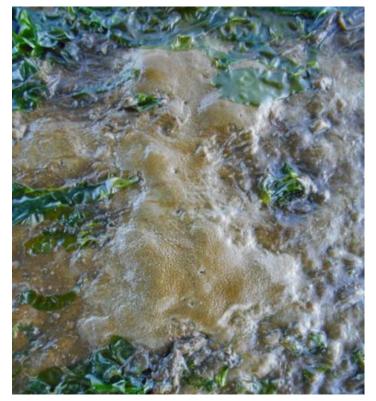
The invertebrate community in the mid intertidal zone was similar to the high zone with colonial diatoms (Figure 3-5) dominant in segment C and balanoid barnacles present throughout. Depending on the available bare rock space and the amount of crevices, the California mussel was also observed occurring occasionally in the riprap areas of survey segments C and D. Both live and dead carapaces of the shore crab *Hemigrapsus sanguineus* were also observed.

Figure 3-5 Colonial diatom.

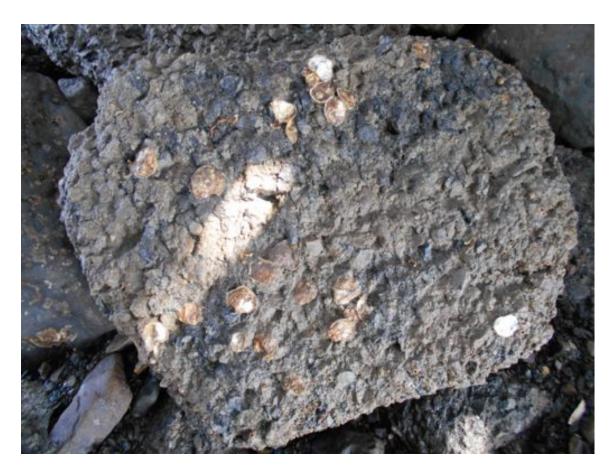
Figure 3-6 Ostrea lurida (conchaphila) and oyster scars.

The native oyster, *Ostrea lurida (conchaphila)*, was observed on concrete and brick debris under the covered pier at the VMT site in the lower intertidal zone. Native oysters were not observed anywhere else in the intertidal zones of the VMT site. Its occurrence under the pier was characterized as very patchy with only a few pieces of concrete or brick rubble showing signs of recruitment (scars) and living oysters. The live oysters ranged between 13 and 24 mm in length and were observed on the surface or vertical faces the rubble. No oysters were observed attached to the pier pilings or the concrete bulkhead. The protected environment under the covered pier segment appears to prevent predation by birds (oyster catchers) when ultra-low seasonal tides expose the inhabited rubble as well as reduce desiccation during exposure to the air.
